Manual, Remake thread M10 for spinner shaft

DWG NR / NAME: Z4-146 / Input socket & brakespinner				BATCH NR:	
PROJECT: Brake all steerer				REKV.NR / ORDRE NR:	
DATE: 29-01-2009	NAME: KJ	SCALE / PAPER: 1.5:1 / A4	MATERIAL:	LOCATION:	ORDRE DATO:
MODIFY DATE: : /			WEIGHT: g	REV:	LEV.DATO:

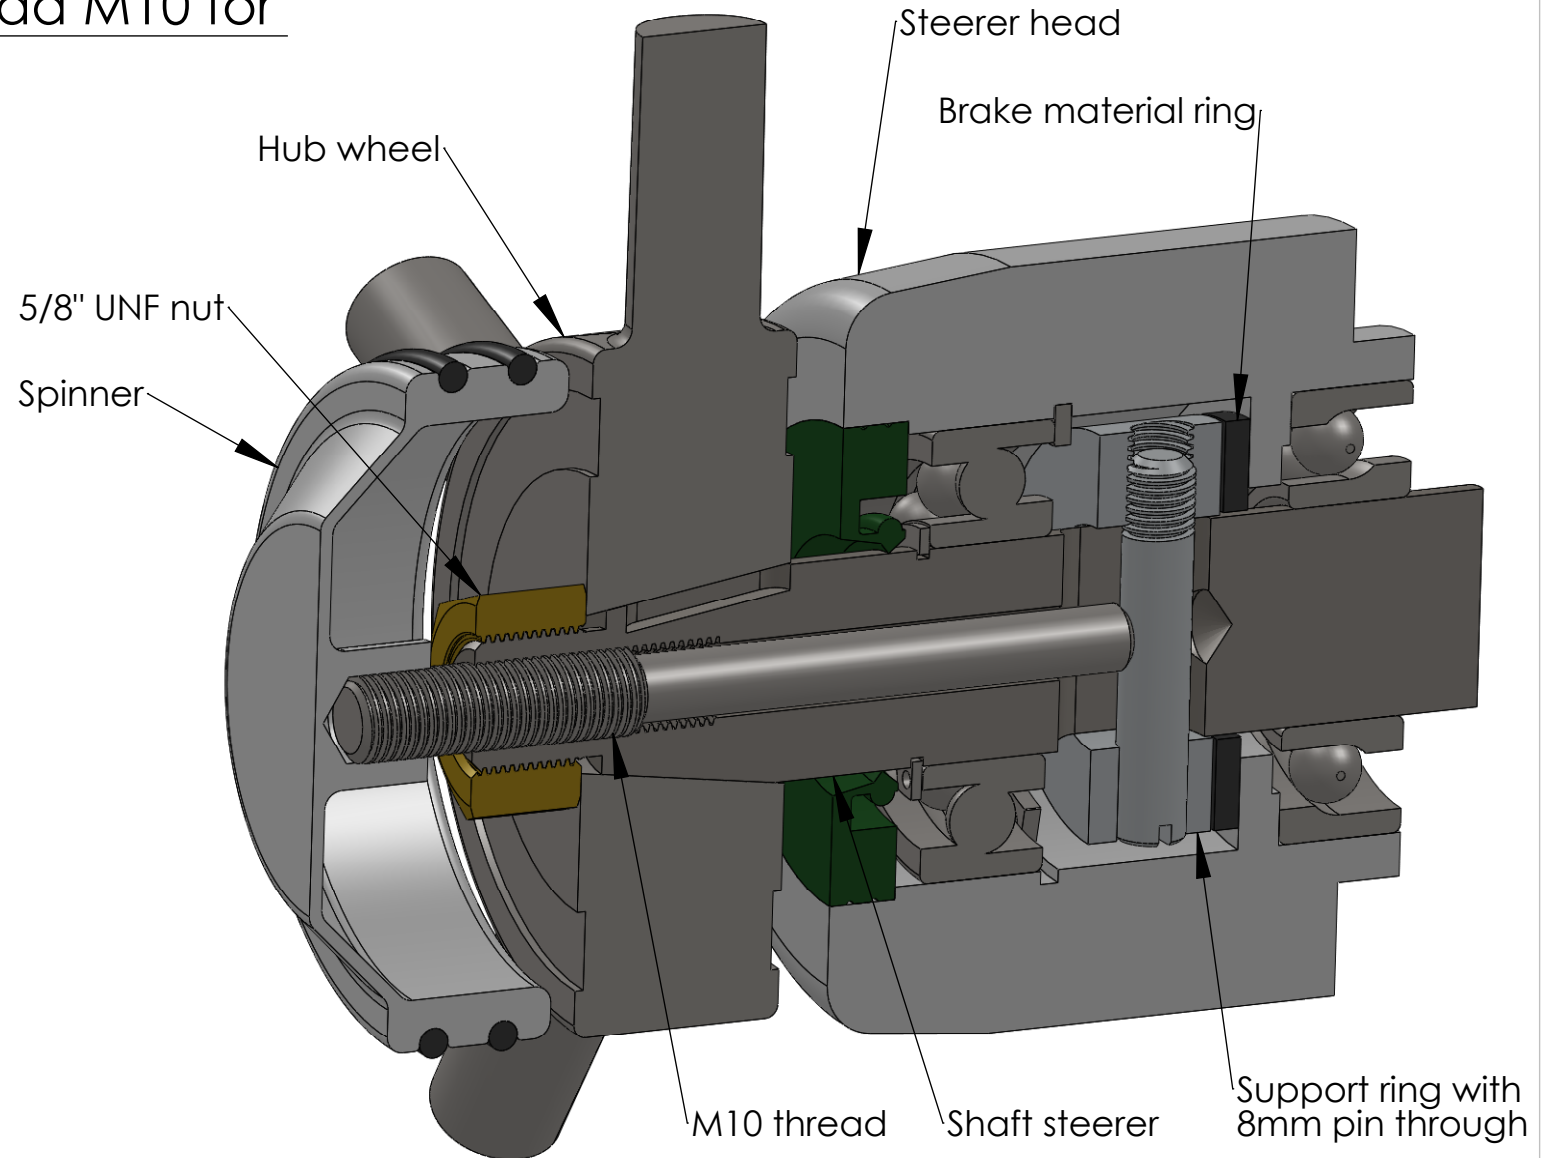
When the wheel is tighten very hard with the 5/8" UNF nut, the inside M10 thread is deformed a little and cause a bad function for the wheel brake.

This problem is solved with remaking the inside M10 thread.

1. Dismount spinner.
2. Remake the thread with a M10x1,5 tap.
Thread depth 25mm.

OBS: [Remember to use grease/oil for the tap to avoid the tap breaking in the wheel shaft.]
